Budget Worksheet Listing

TOWN OF MOULTONBOROUGH

FIRE APPRARATUS NEEDS ANALYSIS

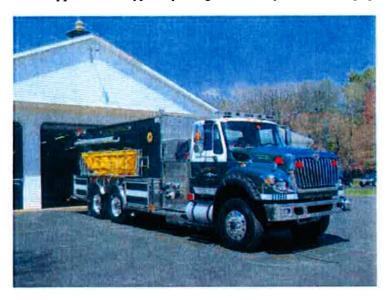
Dry-Side Tanker

These apparatus are typically designed to carry additional equipment and hose loads.

Barnstead, NH. 2012, 3,000-gallon tank, 750 GPM pump, \$353,000. The Town of Sandwich authorized a \$380,000 purchase of a similar unit in the 2013 Town Warrant.

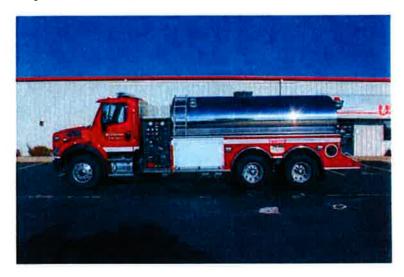
Elliptical Tankers

Elliptical tankers are generally less costly; however there is a trade off in a loss of compartment and hose bed space.

Woodbridge, CT. 2,500-gallon tank, 1,000 GPM pump. Low bid awarded \$299,859 in January 2013.

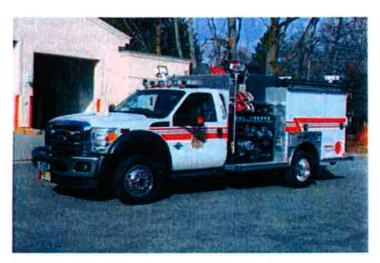
Initial Attack Apparatus- NFPA defines this as fire apparatus with a fire pump of at least 250 gpm (1000 L/min) capacities, water tank, and hose body whose primary purpose is to initiate a fire suppression attack on structural, vehicular, or vegetation fires, and to support associated fire department operations.

Initial attack fire apparatus as defined in NFPA 1901 is fire apparatus with a permanently mounted fire pump of at least 250-gpm capacity, water tank, and hose body whose primary purpose is to initiate a fire suppression attack on structural, vehicular, or vegetation fires and to support associated fire department operations. As can be seen from the definition, these types of apparatus can vary dramatically according to the department's intended use
